Ceiling Failure Restoration
Camberwell, London, SE5

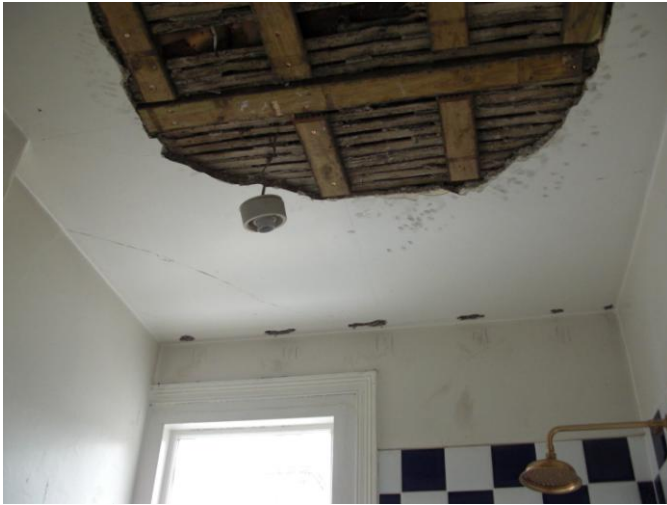
Before: Collapsed ceiling

- Due to excess weight in the loft space above, significant cracks appeared in the bathroom ceiling below.

- ✓ Once it was assessed that there was too much weight on the ceiling above, Abberly Property re-organised the loft and provided strengthening works to the loft floor.
- ✓ A new bathroom ceiling was installed and decorated.
- ✓ The client was provide with a safe and refreshed bathroom environment within 48 hours of initial notification.

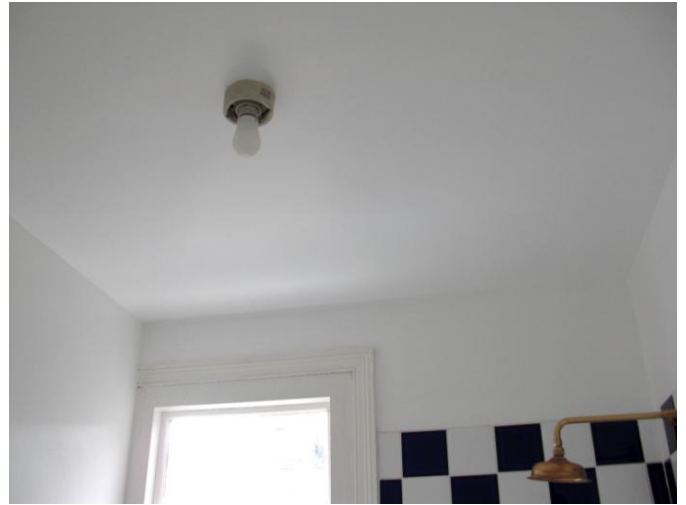
After: Reinstated
